## Replacing the safety catch support

Artikel-Nr.: TP26  
Hersteller: Krömer  
EAN-Code: 0757284116582

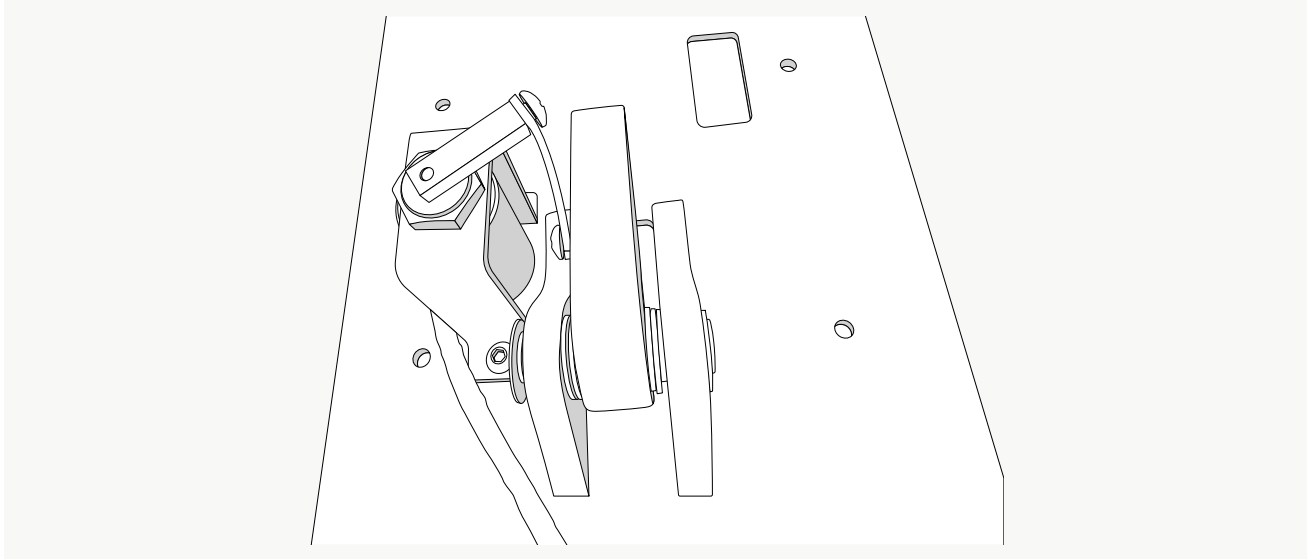
**1** Starting situation

**Problem:** Safety catch does not work to 100%.

**Cause:** Improper assembly or transport damage.

The electromagnet of the safety ratchet is not sufficiently secured and therefore the ratchet does not function smoothly.

**Solution:** Replacement of the holding bracket of the electromagnets or the customer's own fixation of the electromagnet.
