## Replacing the safety catch support

Artikel-Nr.: TP26  
Hersteller: Krömer  
EAN-Code: 0757284116582

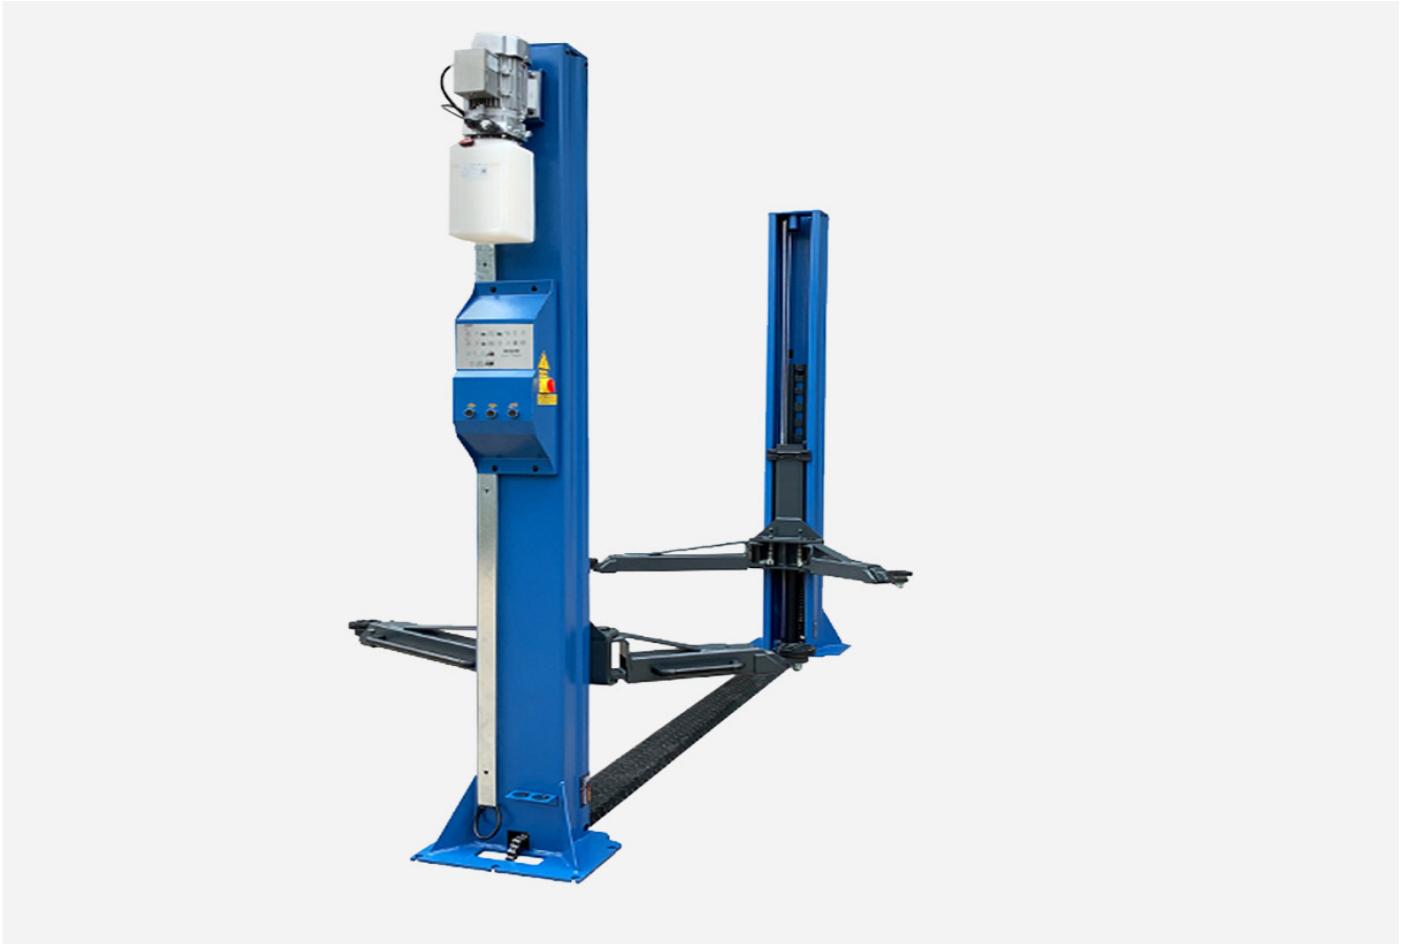
**Problem:** Safety catch does not work to 100%.

**Cause:** Improper assembly or transport damage.

**Solution:** Replacement of the holding bracket of the electromagnets or the customer's own fixation of the electromagnet.
